## APPENDIX A

# REPORT ON THE INSTALLATION OF THE NATIONAL CORS PROTOTYPE MONUMENT

Written by  
Dennis A. Hoar  
Team Leader  
Process Action Team 20  
July 2000

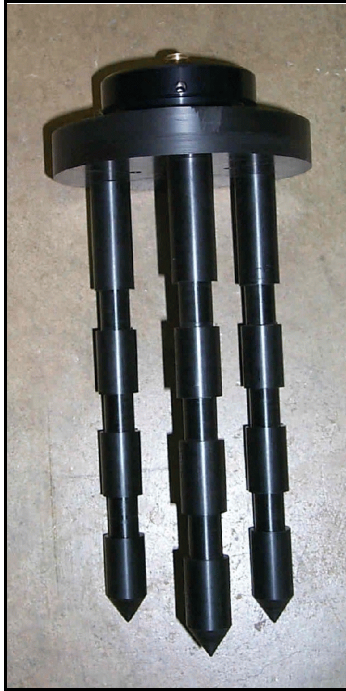
**Figure 1**

Shep Cofer performed the machining of the materials for the antenna mount (Figure 1). A lathe was used to smooth the edges of the 6-in.-diameter Delrin plate. The 1-in.-diameter Delrin rod was cut into three 1-ft.-long legs. Threads were machined at one end, a point

machined at the other, and grooves machined in the sides to provide a place for the concrete to grip the legs. Holes for the legs and studs were drilled and tapped into the 6-in.-diameter plate. Three studs were machined from the 5/16- by 1-1/2-in.-long stainless steel bolts. The legs and studs were screwed into the plate. The feet were removed from a standard rotating tribrach adapter, the tribrach adapter was then placed onto the studs, and the set screws were tightened. The standard locking screw was removed from the adapter and replaced with a 10-32 by 1-1/2-in.-long stainless steel socket head cap screw. This will allow for tightening the locking screw after the antenna is in place. This antenna mount was placed in the top of the concrete pier.

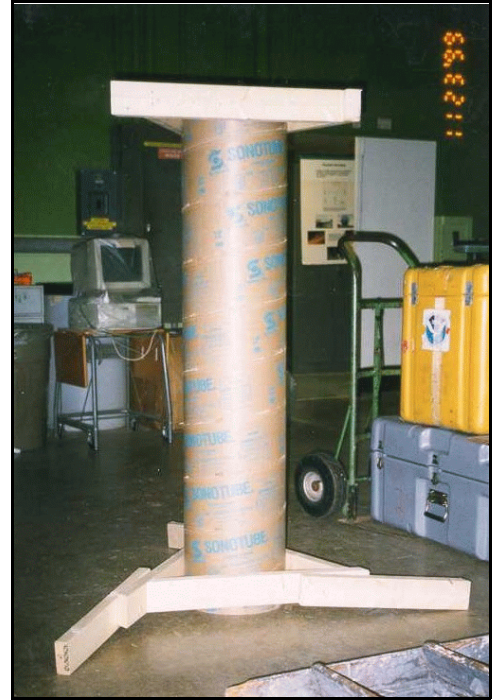
**Figure 2**

A form (Figure 2) for the 5-ft.-long pier portion of the monument was constructed out of a 12-in.-diameter, 12-ft.-long Sonotube (12 ft. is the shortest standard length available). The height of the pier was limited to 5 ft. not only to ensure that the center of gravity remained well below ground but also to allow precise levels to be used in determining the orthometric height of the top of the antenna adapter, i.e., the antenna reference point (ARP). Thus, a 5-ft. length and a 1-ft. length were each cut from the Sonotube. Six pieces of 2x4 lumber were cut into 30-in. lengths with one end beveled at 60 degrees. Three each of these 2x4 lengths were attached in a triangular shape to the top and bottom of the 5-ft.-long form. These constructions were used to attach braces to the form to hold it in place during the pouring and curing of the concrete. The 1-ft. section of Sonotube was used to mark the approximate center of the mass of concrete poured into the ground. This simplified the process of placing the 5-ft. form in the correct position.

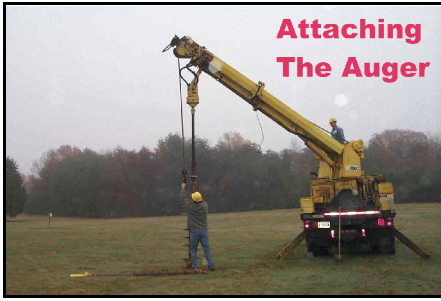
Figure 4

The auger truck arrived 8:10 on November 23 at the selected monument site that was pre-approved as a safe location to dig by "Miss Utility." The truck is owned by the Rappahannock Electric Cooperative and was outfitted with a 21-in.-diameter flight auger capable of drilling a hole to a depth of 15 ft. The truck was manned by a two-person crew of which one person operated the auger while the other directed the position, angle, and depth of the drilling. It took about 10 minutes for them to set up the rig and to attach the flight auger (Figure 4). The drilling process (Figure 5) took only 15 minutes to reach a depth of 11 ft., 4

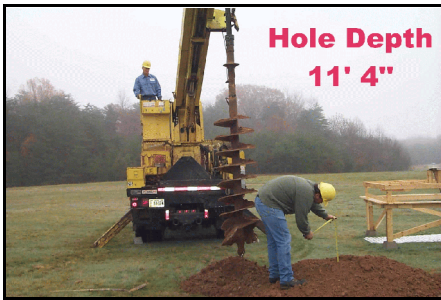
Figure 6

in. (Figure 6). This time period included the operator stopping the drilling to occasionally lift the auger out of the hole to clear away excess soil from the hole and flight augers. The ease with which the hole was drilled is attributed to the local soil composition of loam, sand, and clay. The top 1 ft. was loam, followed by a layer of sand, and the remaining soil was clay. This soil composition was soft and dry, but contained enough moisture that the surrounding soil did not collapse into the hole. The diameter of the finished hole was 22 in. The water table was of sufficient depth that water did not seep into the hole, even after setting overnight. This was an unexpected bonus since the presence of water would have complicated the pouring of the concrete. The truck departed at 8:45, for a total of 35 minutes on site.

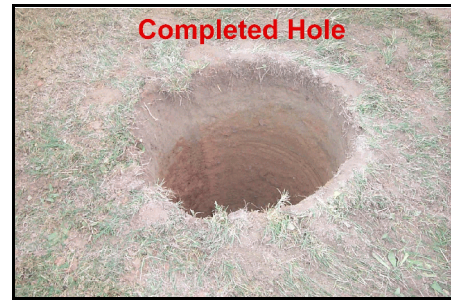
Figure 7

The large pile of soil was then removed from around the hole (Figure 7). Eric Murray of the U.S. Geological Survey volunteered to operate his agency's front end loader to assist in the removal of the soil. This greatly reduced the amount of manual labor required to accomplish this task. It took almost twice as long (1 hour) to remove the soil as it did to drill the hole. The soil was hand shoveled into the bucket of the front end loader to minimize the possibility of soil falling back into the hole. The soil was then spread over low areas near the monument to smooth out the grounds.

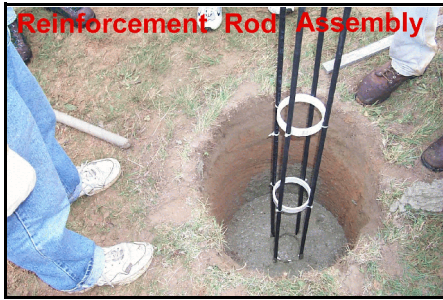
**Figure 10**

This process was repeated until the hole was filled to within a couple of feet of the ground surface. At this point the reinforcement rod assembly was centered into the hole and pushed down into the concrete until approximately 2 ft. of the assembly was above the ground level (Figure 10). The pouring was resumed until the concrete was within a couple of inches of the ground surface. The 1-ft.-long section of Sonotube was placed over the rod assembly and, after measuring to ensure that the rod assembly was in the center, was gently pushed down into the concrete just enough to make a small indentation that could serve as a guide for centering the 5-ft.-long form (Figure 11). The 1-ft. piece of Sonotube was then removed and replaced with the 5-ft. form (Figure 12). Wooden stakes were driven into the ground next to the bottom wooden triangle that was attached to the form, and a 24-in.-long hand level was used to level the form before securing the triangular sides to the stakes using sheet rock screws (Figure 13). Long 2x4s were then attached to the top wooden triangle and secured to stakes (Figure 14). This arrangement was designed to hold the form securely in place while it was filled with concrete. The pouring of the concrete resumed at an even slower pace to ensure that the level would be maintained. The operator of the concrete truck advised against using the concrete vibrator inside the form as there would be a good chance that the force of

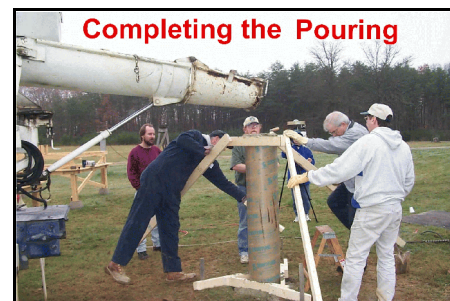
**Figure 15**

the vibrator settling the concrete would rupture the form. A section of a 2x4 was used instead of the vibrator to tamp down the concrete after about 2 ft. of concrete had been poured into the form. This process was repeated until the concrete was about 1 in. higher than the form (Figure 15). The bracing worked as intended, as the form did not move out of level. This concluded the concrete pouring phase of the monument construction. The concrete truck departed the Corbin facility at about 10:00, for a total of about 1 hour on site.

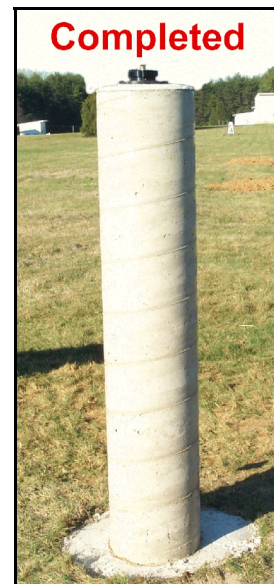
**Figure 21**

The concrete mix was not as stiff as the Team had desired, causing some of the concrete to ooze out around the bottom of the form. (For durability, a maximum water-to-cement ratio by weight of 0.50 is recommended for concrete exposed to freezing and thawing in a moist environment.) This “oozing” at the bottom of the form did not appear to jeopardize the integrity of the monument, but the Team nevertheless decided to let the concrete firm up for an hour before troweling the top of the monument and inserting the antenna mount. After the delay, the top of the monument was troweled, forming a slight dome shape to prevent water from accumulating on the top of it. The antenna mount was then inserted into the center of the dome (Figure 16) and pushed down until the 1-in.-thick plate was imbedded about 1/2 in. into the concrete (Figure 17). This should prevent water from getting under the plate and potentially freezing and thereby separating the antenna mount from the concrete. The top of the monument was troweled smooth, and an arrow pointing toward true north was then inscribed into the top of the concrete pier (Figure 18) to help with the aligning of GPS antennas during observations. The concrete was allowed to cure for 16 days before the bracing and form were removed from the monument (Figure 19). The bracing and form could have been removed after 7 days; however, because of the cold weather, the team thought it prudent to allow extra curing time. The level of the antenna mount was checked (Figure 20) after the bracing and the form were completely removed, and it was found to be the same as when the monument was installed. The monument installation was completed (Figure 21) except for painting the exterior and installing PVC pipe to protect the antenna cables.

There were two tasks that were not completed at the time of the monument installation due to the onset of cold weather. One task was to paint the pier with a white, waterproof concrete paint to seal the exterior from moisture. The other task was to place PVC pipes underground to protect the antenna cables that will run from the pier to the building that houses the GPS receiver. These tasks were completed in February 2000 after the air temperature remained above the freezing point.
